INDOOR AIR QUALITY ASSESSMENT

**Holyoke DPW
Pellisier Building
63 Canal Street
Holyoke, MA**

Prepared by:
Massachusetts Department of Public Health
Bureau of Environmental Health
Indoor Air Quality Program
August 2016

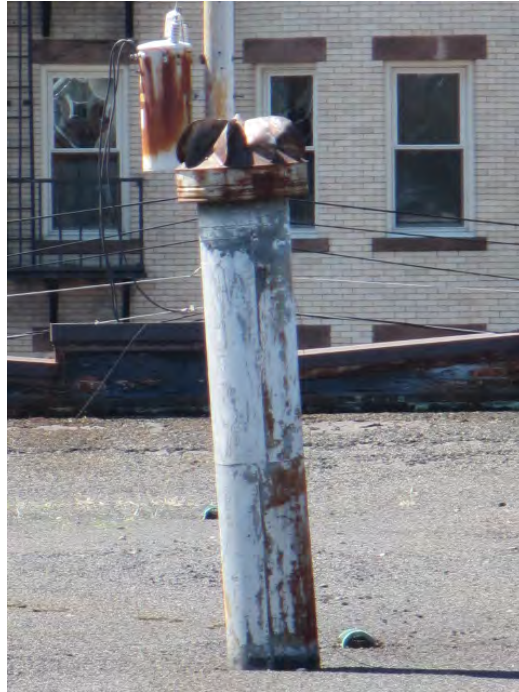
Picture 1

Vehicle bays, where train trolleys were originally stored, have turbine exhaust vents on the roof (Picture 1) and mechanical exhaust fans that were retrofitted into exterior wall windows.

Turbine vent

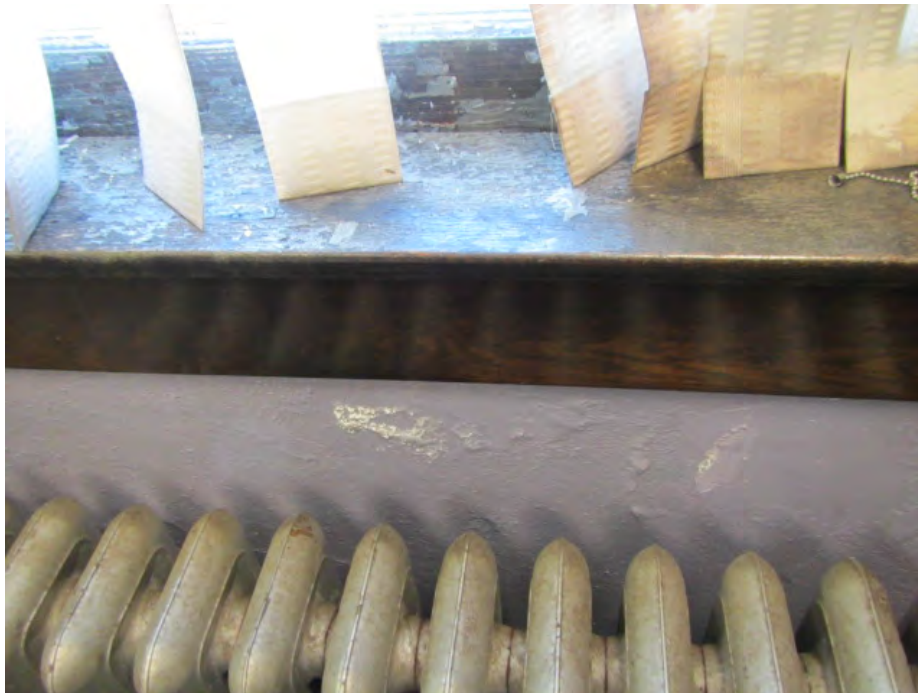
Picture 2

BEH staff were asked to examine the DPW for water damage due to staff concerns and reported health symptoms. It is important to note that the building is primarily constructed of materials such as stone, brick, plaster, and hard wood floors. These materials are unlikely to support mold growth, even when exposed to periodic water leaks. BEH staff did note accumulations of powdery, white material in areas with brick and mortar on the second floor of

the building (Pictures 2 through 4). The white material is called efflorescence; efflorescence is a characteristic sign of water damage to building materials such as brick, mortar, or plaster, but it is not mold growth. As moisture penetrates and works its way through mortar around brick as well as plaster, water-soluble compounds dissolve, creating a solution. As the solution moves to the surface of the wall, water evaporates, leaving behind white, powdery mineral deposits. This condition indicates that water from the exterior has penetrated into the building. Plaster and brick do not typically support mold growth because these materials are not carbon-based; however, paint, items, or debris near the walls that are moistened may become mold-colonized. When present, efflorescence can be readily cleaned.

Efflorescence below first floor window underneath paint

1. Have a building engineer examine the parapet and wall around and below the skylight to determine the best method for remediating water leakage.
2. Have the brickwork throughout the building repointed.
3. Examine the feasibility of installing a fresh air supply and exhaust system to the existing HVAC system.

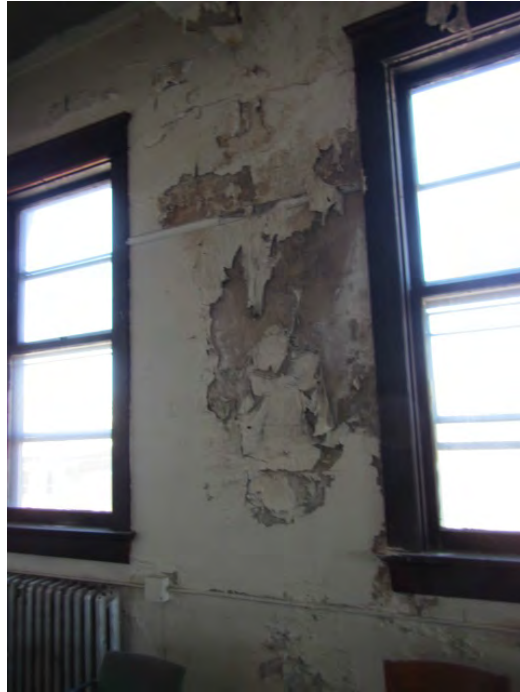
Picture 3

Efflorescence and peeling paint, second floor

5. Repair/repaint areas of peeling plaster on walls and the ceiling. If lead paint is a concern, ensure that lead-safe procedures are used in accordance with the Department of Labor Standards Regulations, 454 CMR 22.

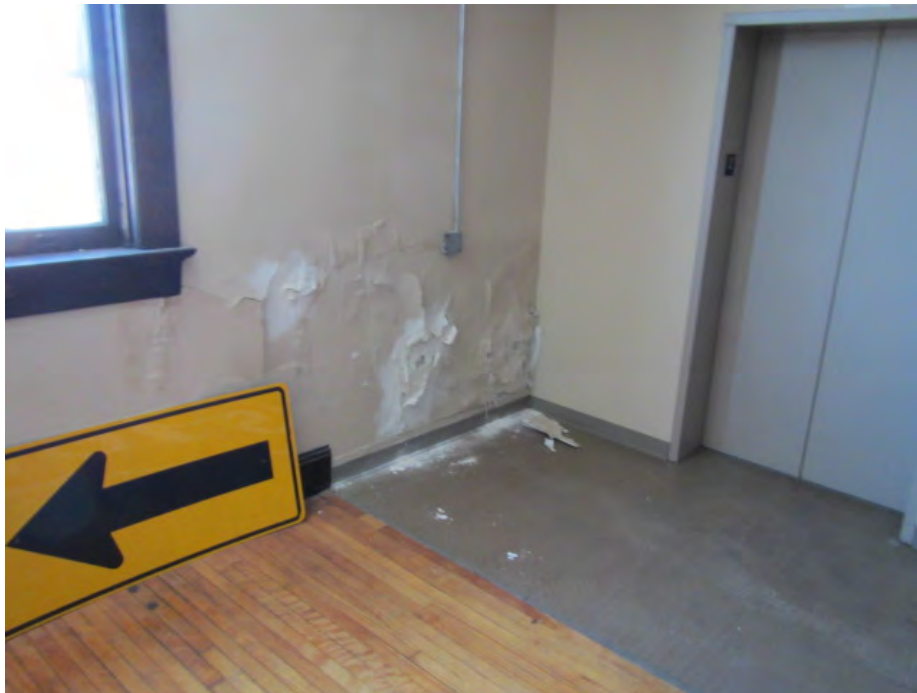
Picture 4

Efflorescence and peeling paint, second floor

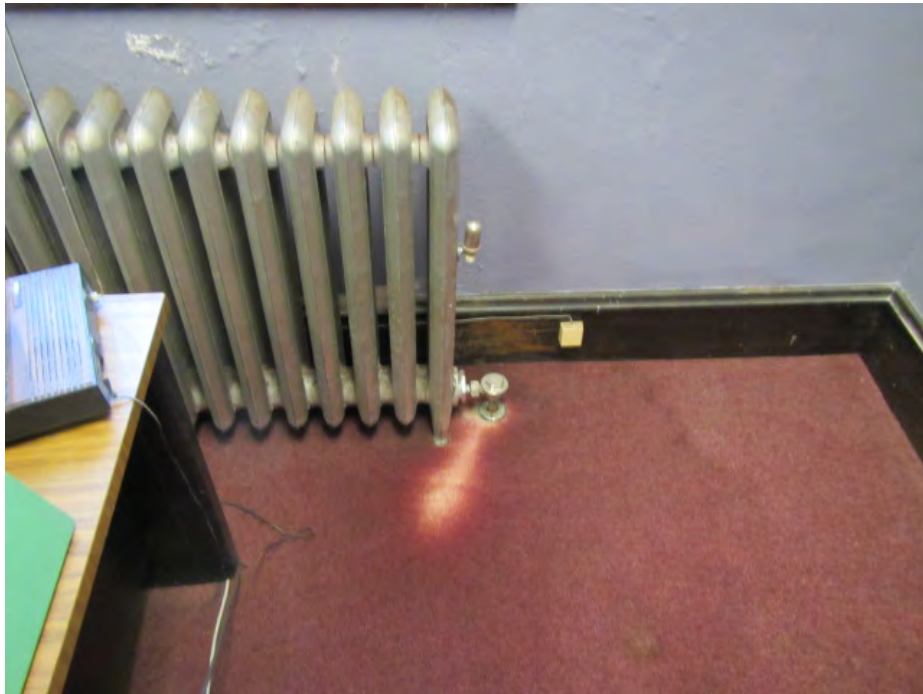
Picture 5

A number of occupied offices contain wall-to-wall carpeting. One carpet appears to have been discolored due to repeated exposure to steam from the office radiator (Picture 5). It is also likely that the wall-to-wall carpet is nearly 30 years old. The average service life of carpeting is approximately eleven years (Bishop, 2002). It was unclear if the building has a regular carpet cleaning program. The Institute of Inspection, Cleaning and Restoration Certification (IICRC), recommends that carpeting be cleaned annually (or semi-annually in soiled high traffic areas) (IICRC, 2012).

Water-damaged carpet

1. Seal the holes and seams in windows of the shared wall of the offices and the garage bay. Install weather stripping and door sweeps on doors.
2. Install carbon monoxide detectors in each occupied level of the building.
3. Remove all water-damaged ceiling tiles in a manner consistent with guideline set forth in the US EPA document, *Mold Remediation in Schools and Commercial Buildings*.
4. Remove carpeting from offices as needed.

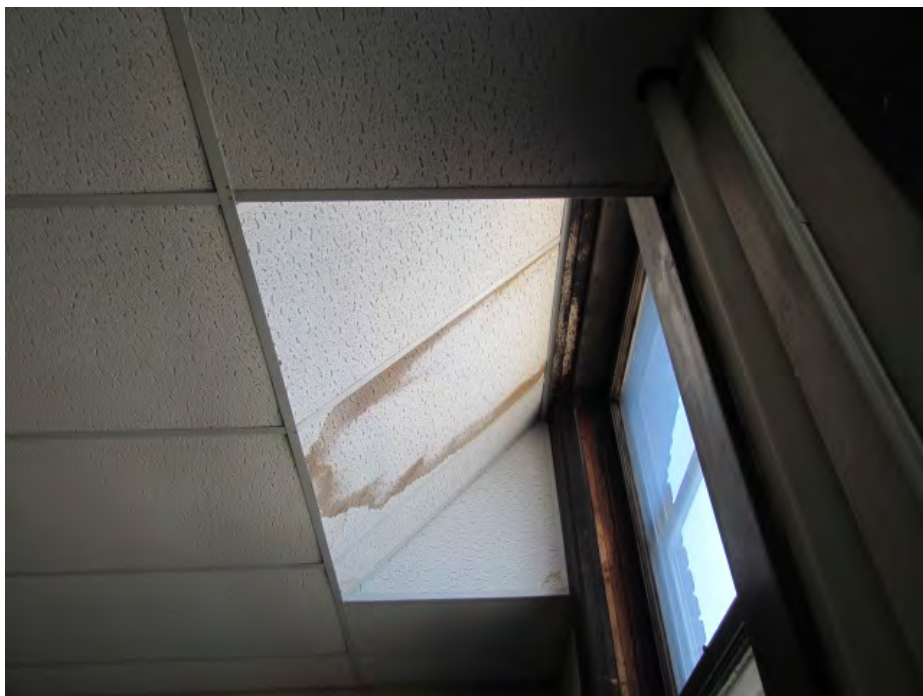
Picture 6

Water-damaged ceiling tiles were observed above windows in some areas (Picture 6). The US Environmental Protection Agency (US EPA) and the American Conference of Governmental Industrial Hygienists (ACGIH) recommends that porous materials be dried with fans and heating within 24 to 48 hours of becoming wet (US EPA, 2008; ACGIH, 1989). If porous materials are not dried within this time, mold growth may occur.

Water-damaged ceiling tile at window

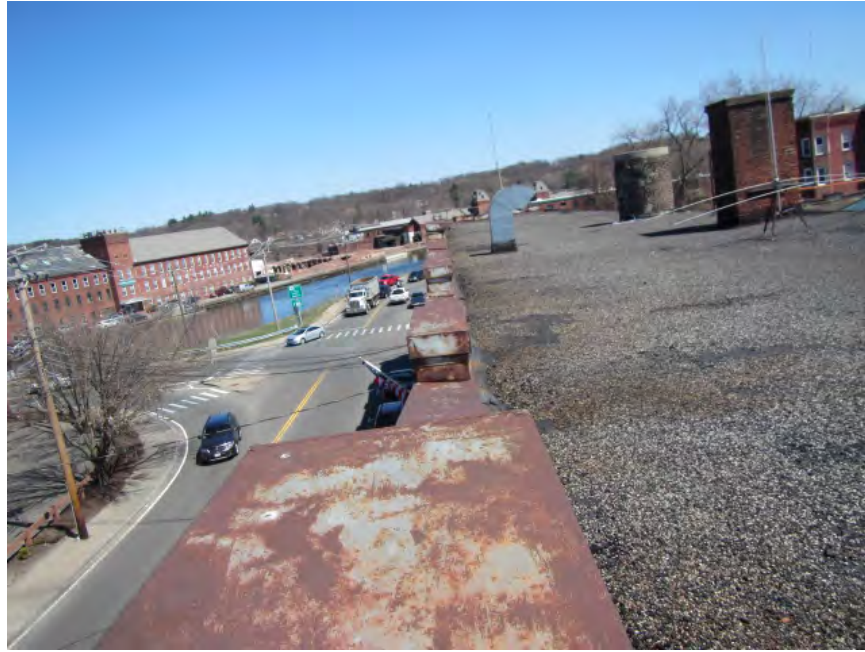
Picture 7

- The front of the building has a roof edge that is topped by a parapet (Picture 7). Parts of the parapet appear to be leaning inwards toward the roof, instead of being perpendicular to the roof. It cannot be determined if this condition was original to the construction of the building or is a sign of progressive movement of the parapet brickwork.
- The back of the roof contains a skylight that appears to be collapsing (Picture 8).
- A large crack in a wall into the garage bay opening was observed near the damaged skylight (Picture 9). Beneath the cracked wall inside the engine bay is a large steel roll-up door. The roll-up door appears to have been retrofitted into the garage bay sometime after

Parapet at front of building

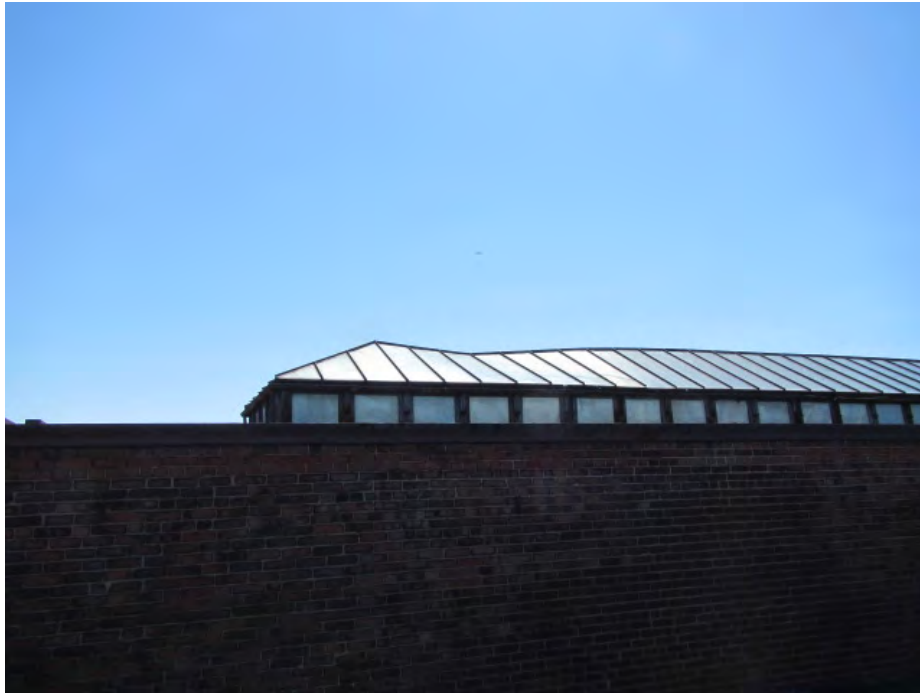
Picture 8

Collapsing skylight

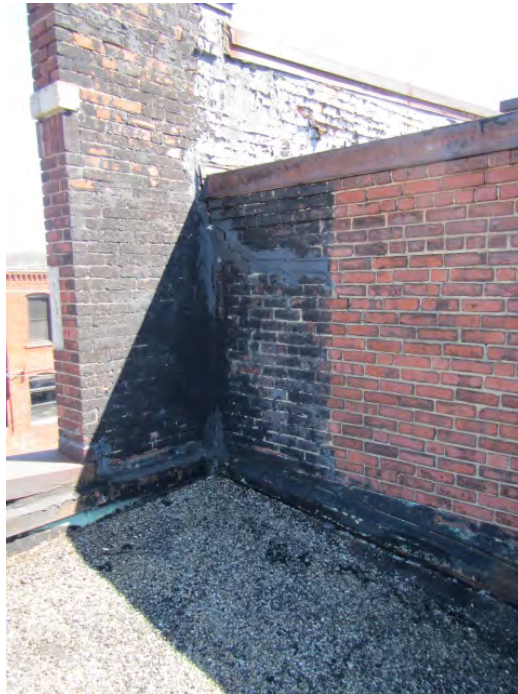
the initial construction of the building. It appears that in order to install the roll-up door, the end of a large steel support beam as well as interior wall brickwork was removed (Picture 10 and 11). The crack in Picture 9 is located directly above the removed steel support beam and brickwork.

These conditions may be a source of water leaks in the building. In order to repair thoroughly, repointing of the wall/brickwork will likely be necessary.

Crack in wall above garage bay

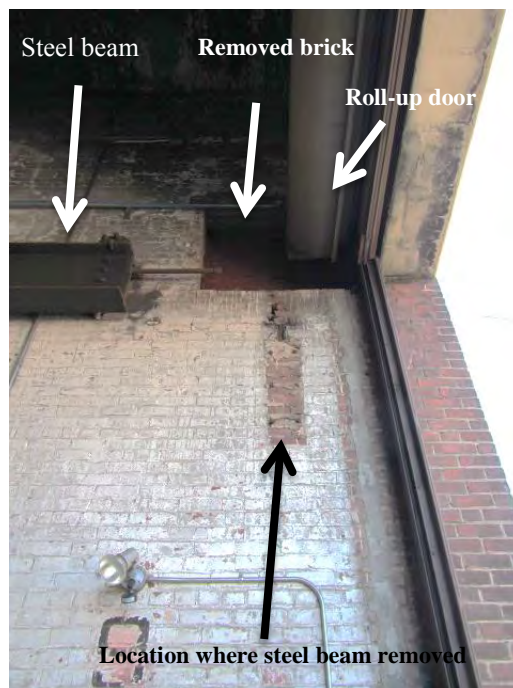
Picture 10

Area below roof wall in Picture 9

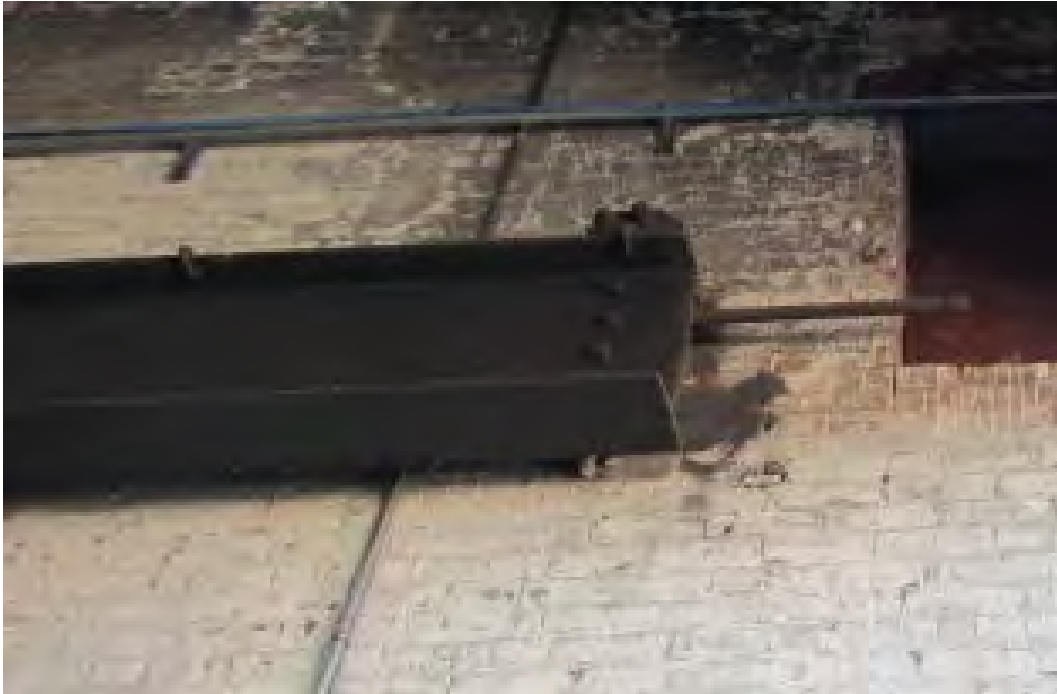
Picture 11

Close-up of cut beam, note uneven end

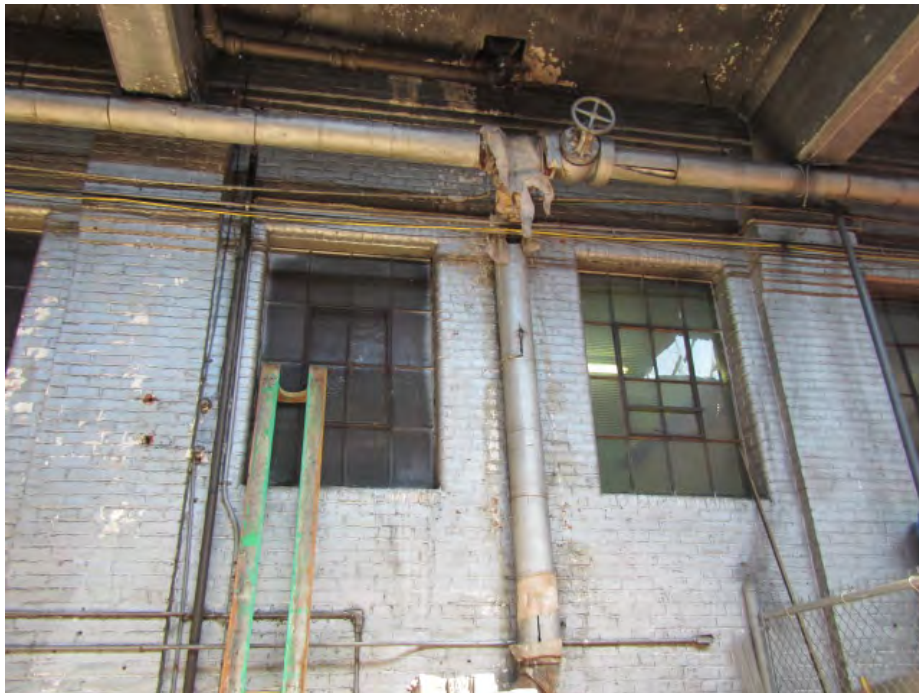
Picture 12

The office area shares an interior wall with the engine bay, which has a number of windows (Picture 12) and doors. Due to wear and age, the windows and doors are not likely to close tightly and likely allow for air from the garage bays to enter into the office areas.

Shared windows between vehicle area and office areas
